November 5, 2013

Comments on the use of Geotubes for the “protection” of Baxter Rd.

Robert S. Young, PhD, PG

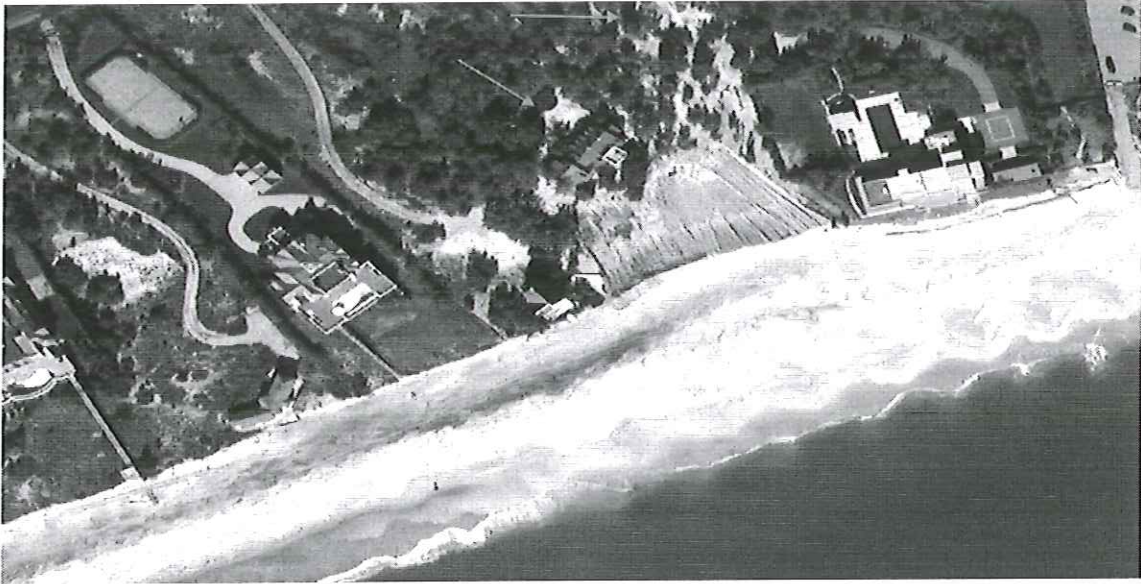
NOAA high-resolution aerial image from Nov. 4, 2012 of Quogue, NY. The red arrows are pointing to sands deposited during storm overwash. This degree of storm penetration and overwash was not seen on properties to the west. It was unique to the property sitting right at the terminus of the geotextile wall.

Hurricane Sandy provided multiple examples of neighboring properties impacted by geotube wall end effect.

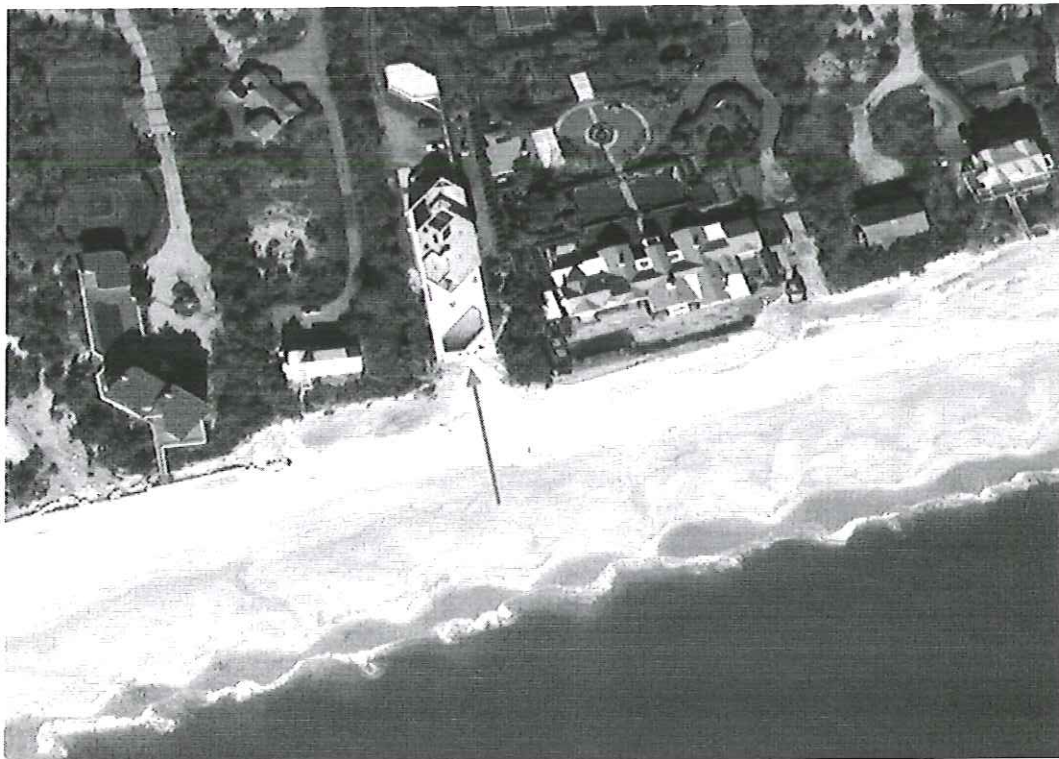
Another property in the Town of Southampton that had increased storm energy and damage as a result of the end effect from a large geotextile wall sitting immediately to the east.
